# Implant Complications: Biomechanical and Esthetic Considerations— A Prosthodontist’s Perspective

Marcus Abboud, DMD, PhD; Leonard B. Kobren, DDS; and Gary Orentlicher, DMD

## ABSTRACT

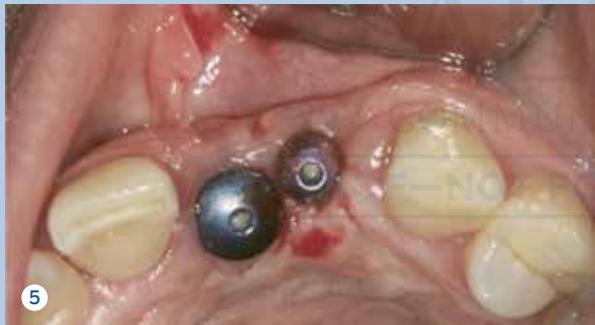
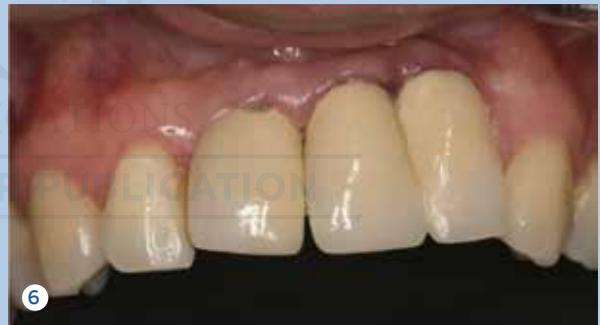
**FIG 5 AND FIG 6.** Example of implants being placed too close together (Fig 5), resulting in a suboptimal outcome (Fig 6). **FIG 7 THROUGH FIG 9.** Design of a provisional restoration based on the patient's anatomy and smile, which will result in an esthetic emergence profile. [Author: Please provide more detail of what is being shown in each of these three figures. Also, is the caption correct as is?]

Less impressive results can be seen in the case shown in Figure 5 and Figure 6, in which implants were placed too close together, resulting in bone loss between the implants. Although the clinician placing the implants was pleased with the result because of acceptable function, it is our opinion that clinicians must be extremely careful when placing several implants next to each other in the esthetic zone. According to Tarnow et al in

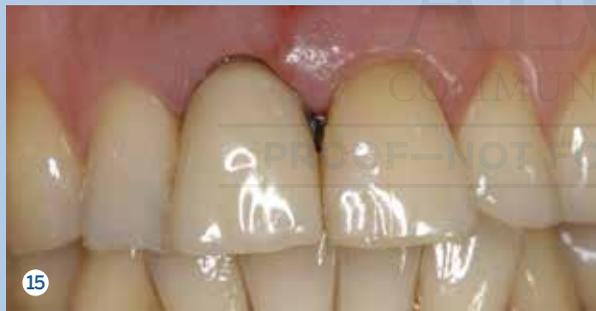
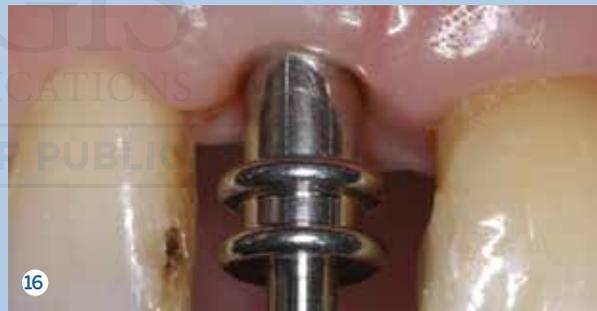
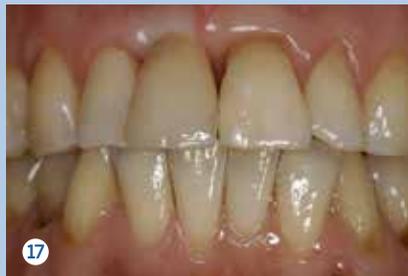
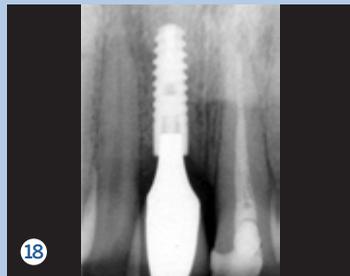
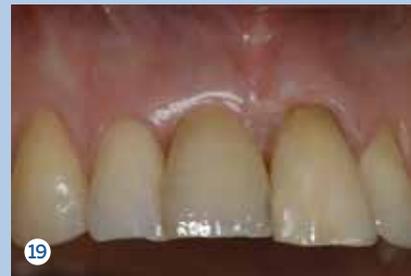
**Fig 15.** Clinical situation after 1 week. [Author: Please expound. "...after 1 week following placement of abutment and crown? ..."] **Fig 16.** Clinical situation after 5 weeks. Both interdental papillae have been lost. **Fig 17.** Clinical situation after 6 weeks. The final restoration has been placed. **Fig 18.** Radiographic situation after 1 year. Note there was no peri-implant bone loss. **Fig 19.** Clinical situation after 1 year. Due to the stable cortical bone and the healthy adjacent teeth the soft tissue slowly regenerated.

The esthetic advantage of a platform-switched implant with a customized zirconia abutment is demonstrated in the clinical

case of a 24-year-old woman who received a provisional restoration after implant surgery (Figure 15 through Figure 19). The provisional was over-contoured, putting too much pressure on the peri-implant soft tissue. A soft-tissue necrosis developed due to inadequate blood supply to the affected area. The prosthodontist was able to save the case by using a customized zirconia abutment and a zirconia crown.
